Restoring a Kansas Farm Pond: Controlling Algae Through Dredging

High Linn Farms — Prescott, Kansas

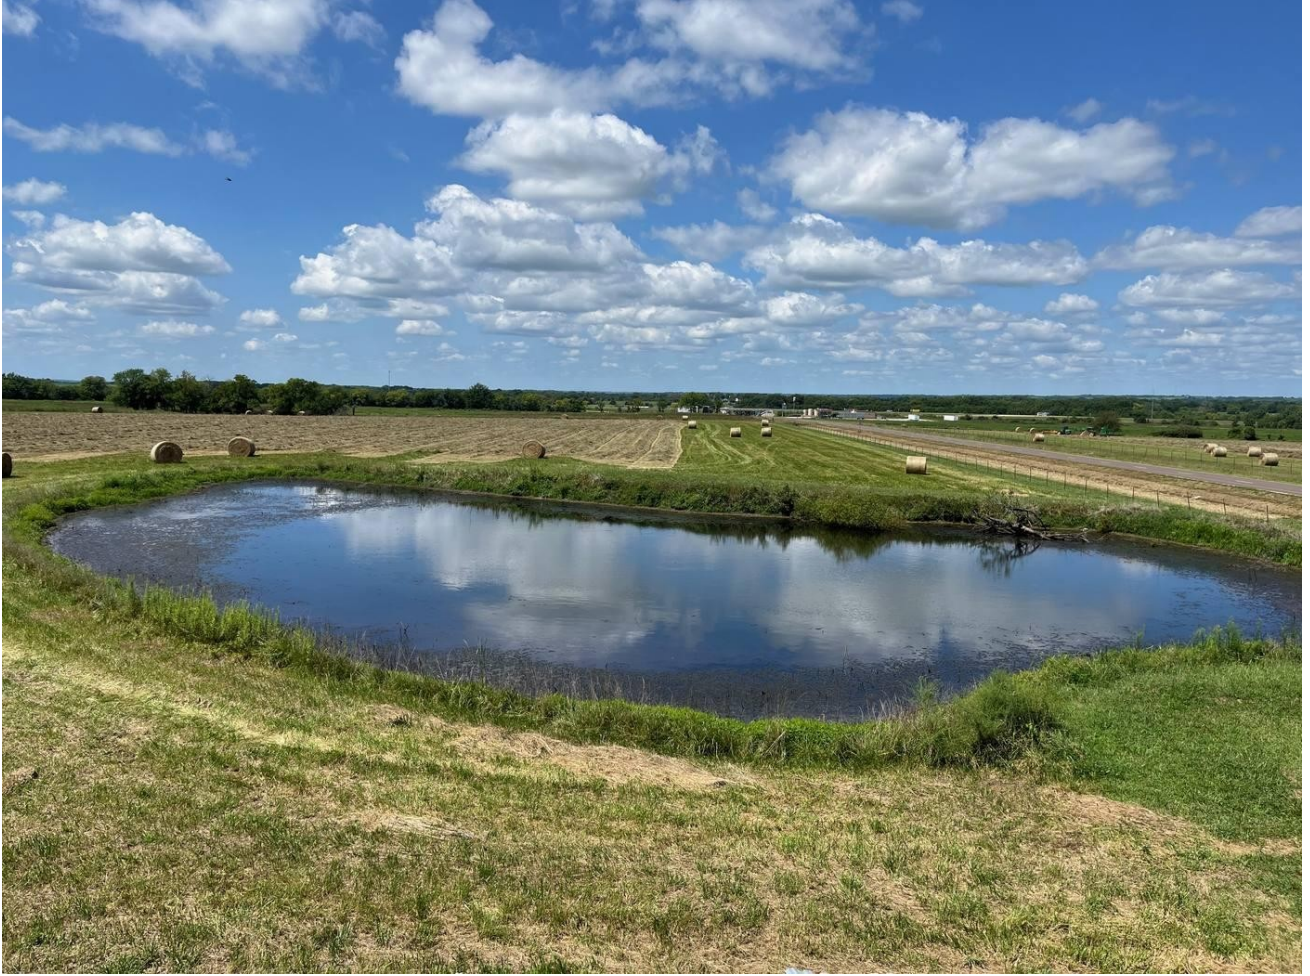
The following photos document the major stages of the pond clean-out process (See Figures 1–5). Over several days, the bulldozer removed decades of accumulated silt, reshaped the pond edges, and restored the original clay bottom. Figure 1 shows the pond before dredging began, when algae had overtaken the surface. Figures 2 and 3 capture the excavation in progress, showing the bank cuts and the removal of accumulated silt. Figure 4 documents the pond immediately after excavation, revealing the restored clay bottom. Figure 5 shows the fully refilled pond, demonstrating the dramatic improvement in water depth and clarity. Together, these images illustrate how dredging directly addresses the root causes of algae growth by increasing depth and improving water quality.

Figure 1. Pond before dredging. (Photo by author.)

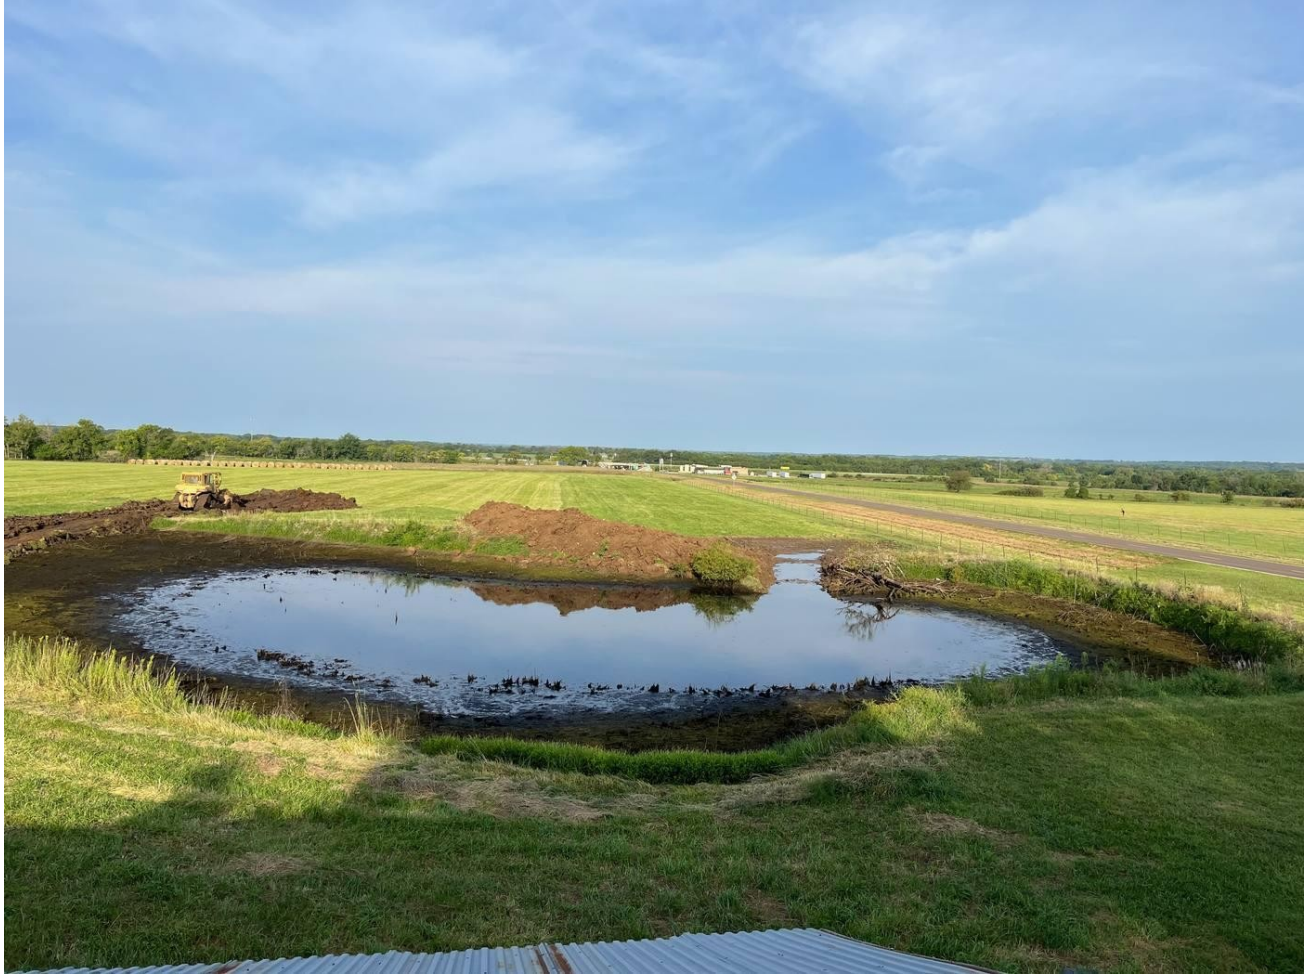
Figure 2. Cutting the bank. (Photo by author.)

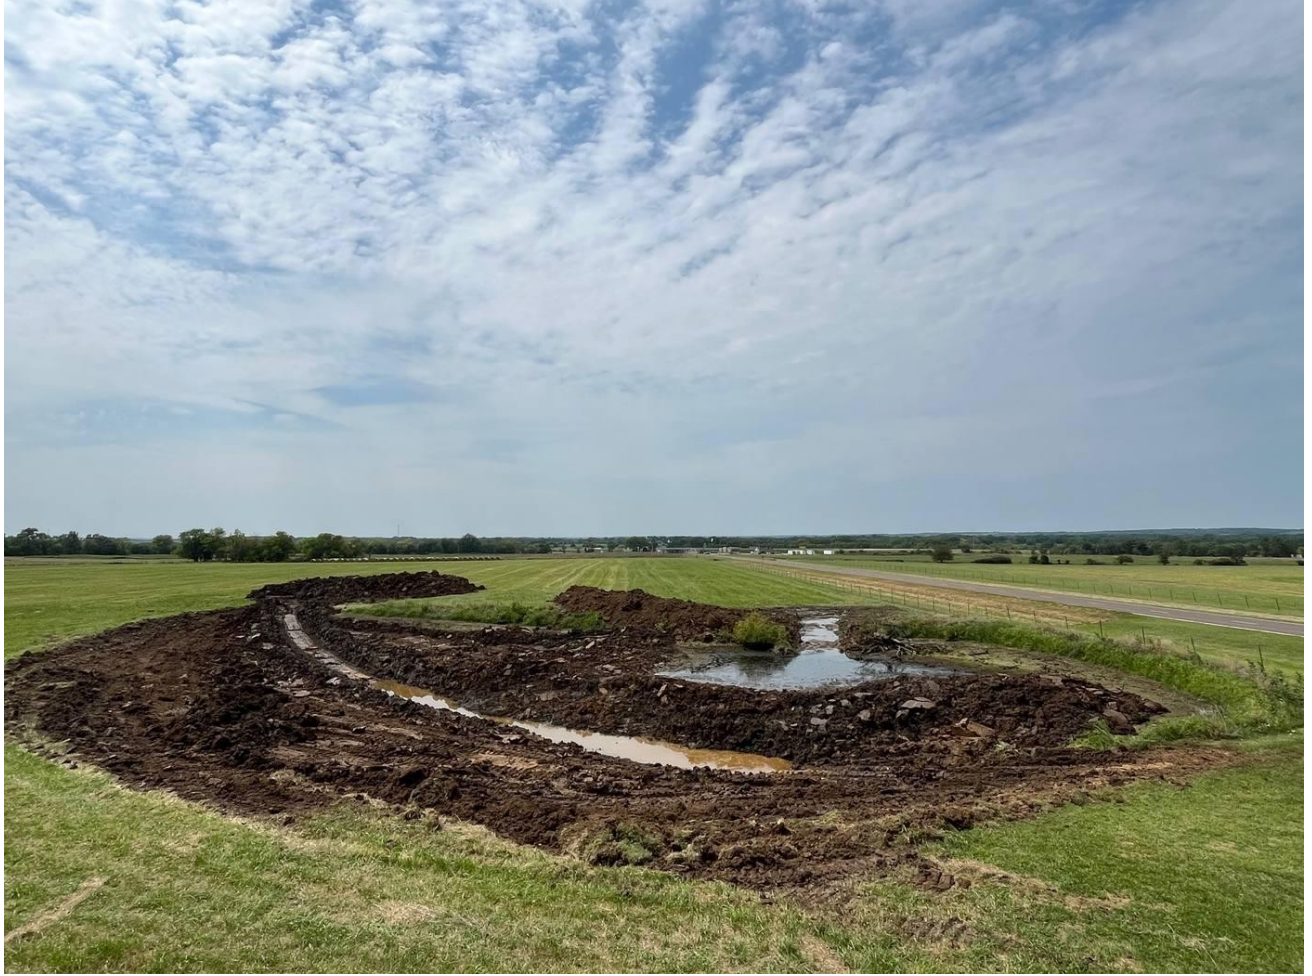
Figure 3. During excavation. (Photo by author.)

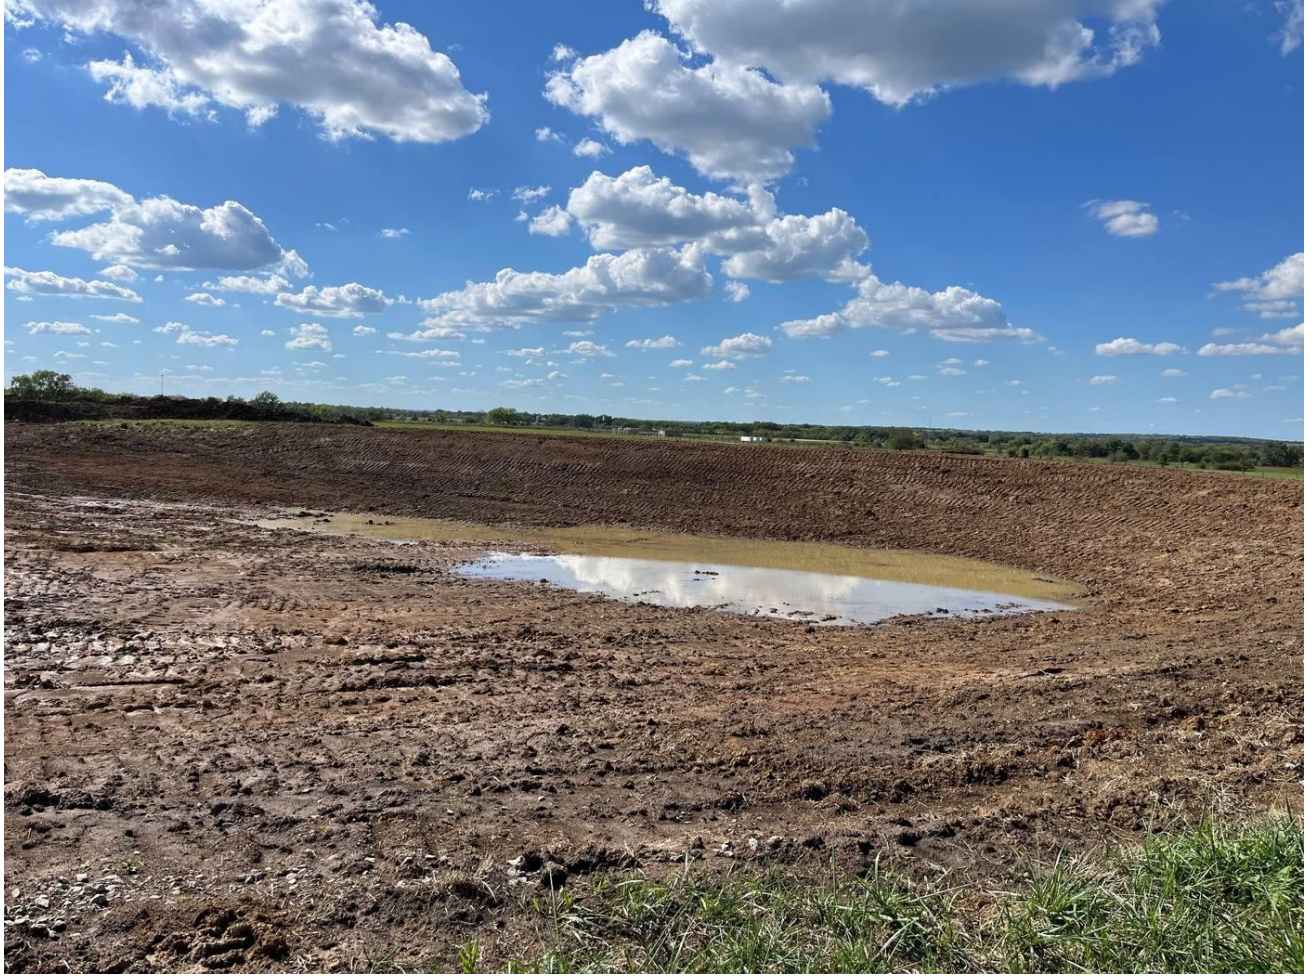
Figure 4. After excavation. (Photo by author.)

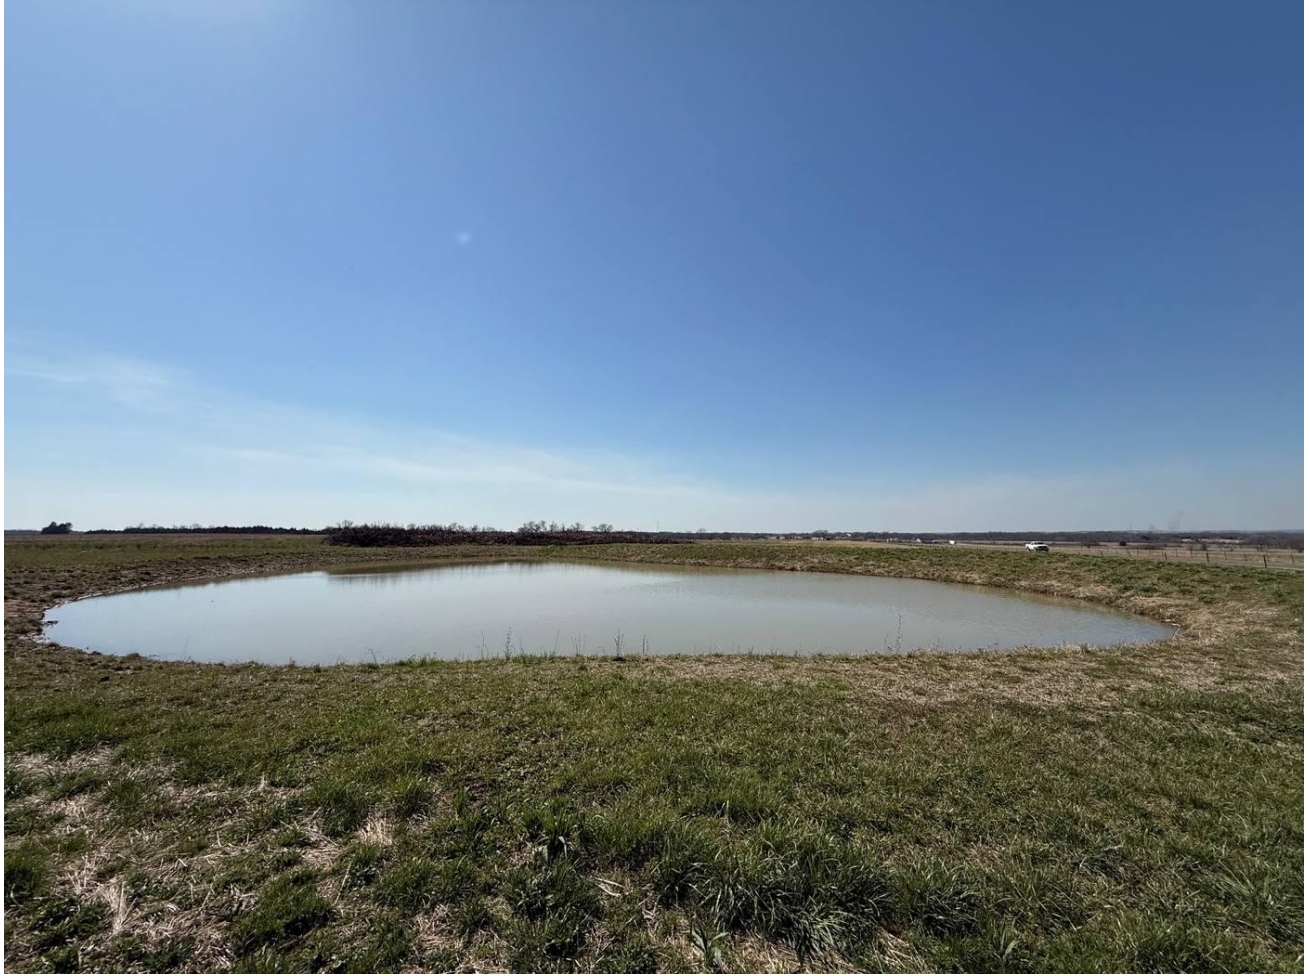
Figure 5. Full pond. (Photo by author.)
